# Manhole Inspection Summary

Manhole # S17AA1025MH

Insp Date: **6/25/07 9:51 AM**

**Location** Address: **2300 GREENSPRING AVE**

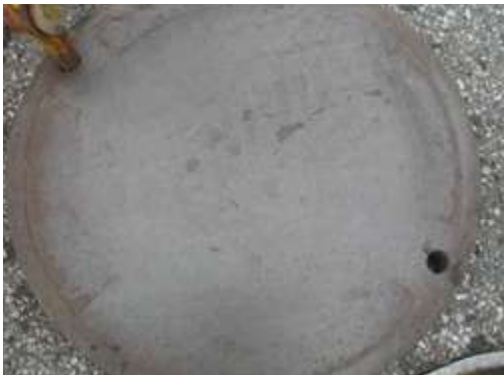
Defect

Condition: **Worn**

Worn cover.

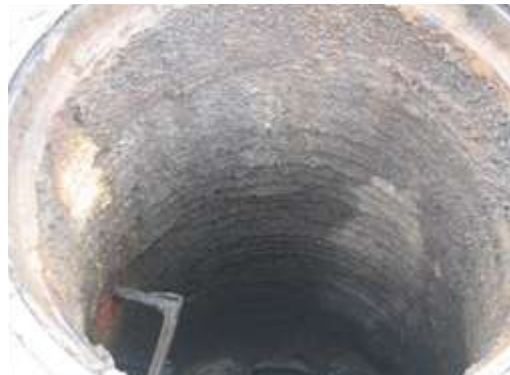
Defect

☒ **Leaks**

Infiltration: ☐ None ☒ **Joint** ☐ Cracks ☐ Mortar ☐ Roots ☐ Wall

Frame leaks. Adjustment infiltration.

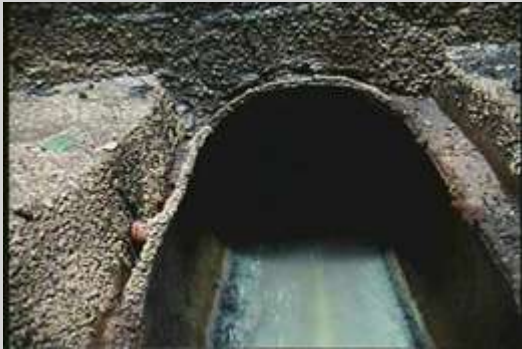
### 15 in. Circular Gravity Sewer Pipe Out @ 12 O'Clock

Infiltration: **Evidence** Pipe Seal Cond: **Unknown**

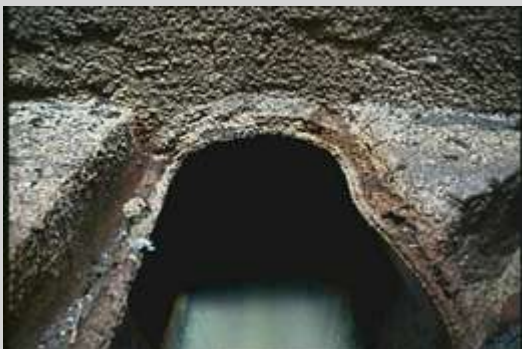
### 15 in. Circular Gravity Sewer Pipe In @ 6 O'Clock

Infiltration: **Evidence** Pipe Seal Cond: **Unknown**

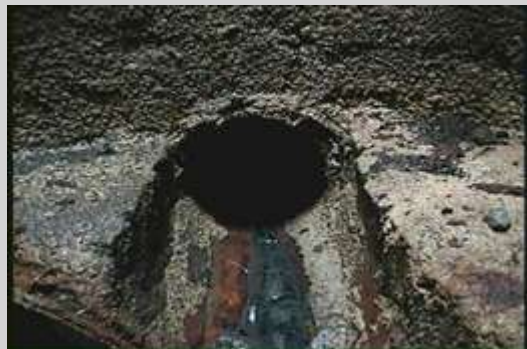
Pipe In @ 8 O'Clock

Infiltration: **Evidence**
